GSFC • 2015

Lessons Learned during the Refurbishment and Testing of an Observatory after Long- term Storage

John Hawk, Sharon Peabody, and
Richard Stavelly
NASA Goddard Space Flight Center

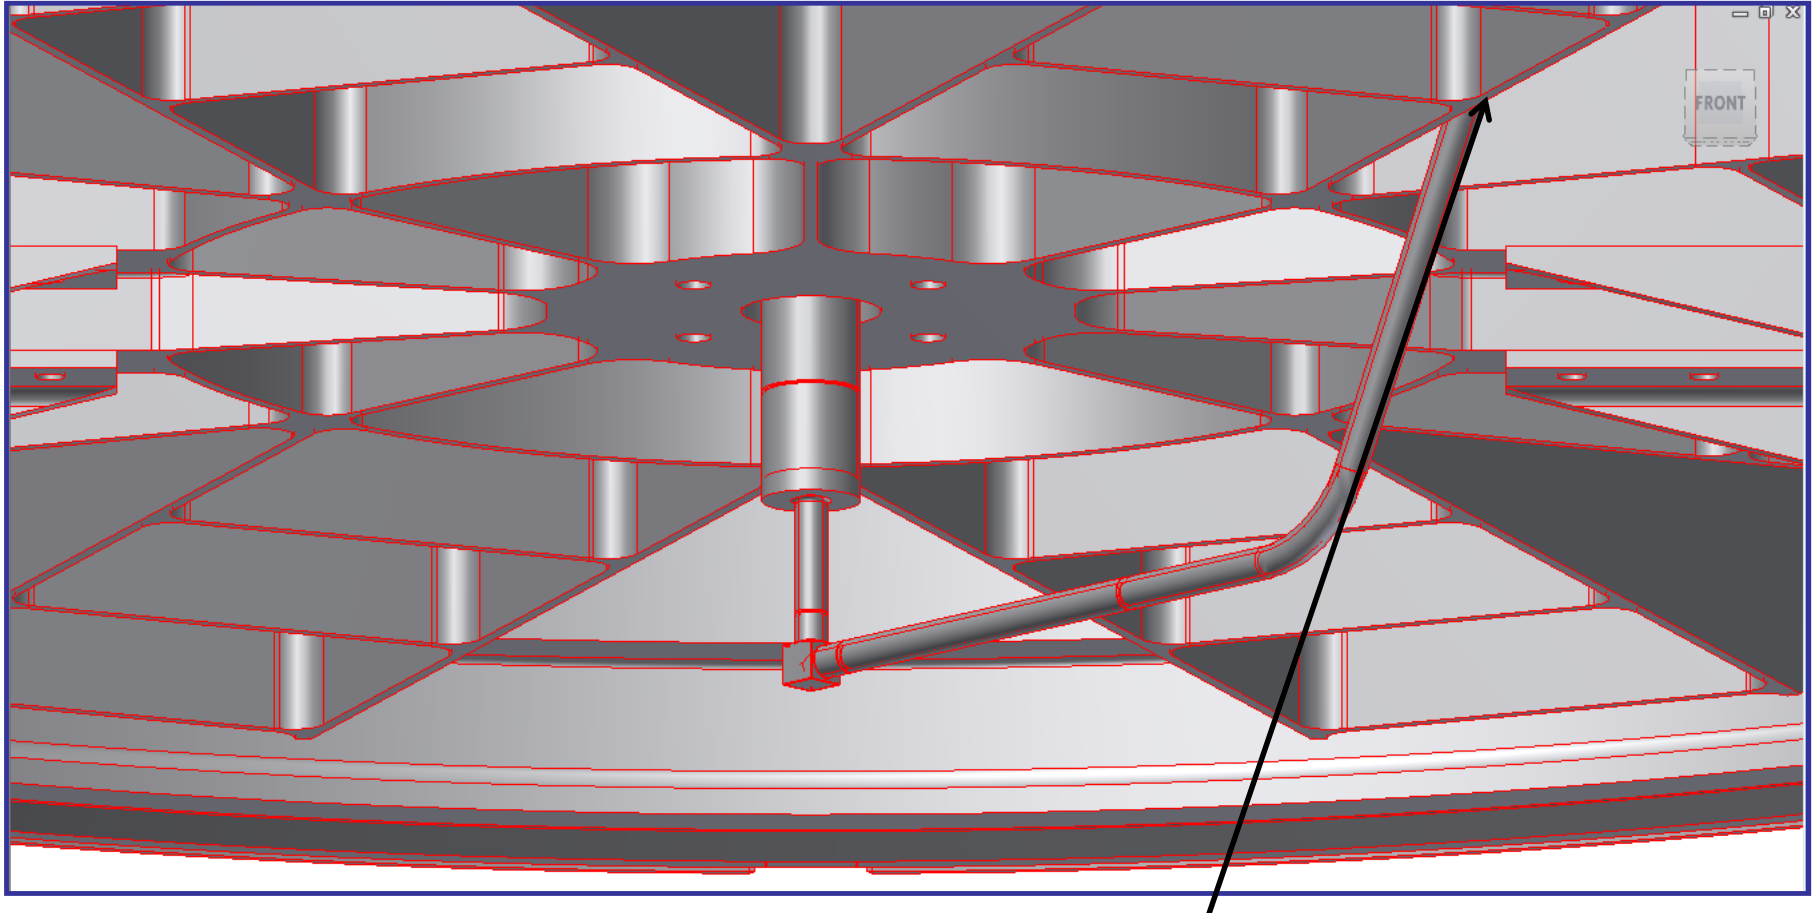
External Run of Propulsion Line Zone 5

Propulsion Line Heater Zone 5 Heater Control located inside the prop module
Med Control Thermistor On @ 24°C Off @ 26°C
Low Control Thermistor On @ 18°C Off @ 20°C

- Further examination of the thermal balance test data from TRIANA testing revealed the same propulsion line 5 behavior.
- On the external run, an auxiliary dual element heater with a pair of series redundant thermostats had to be installed over the existing line 5 heater.
- The added thermostats were chosen with control points lower than the existing electronic controller set-points so that the auxiliary heater wouldn't impact the function of the existing heater.
- Structural analysis had to be performed to assure that there was no impact due to the added thermostat, heater, and aluminum tape masses.

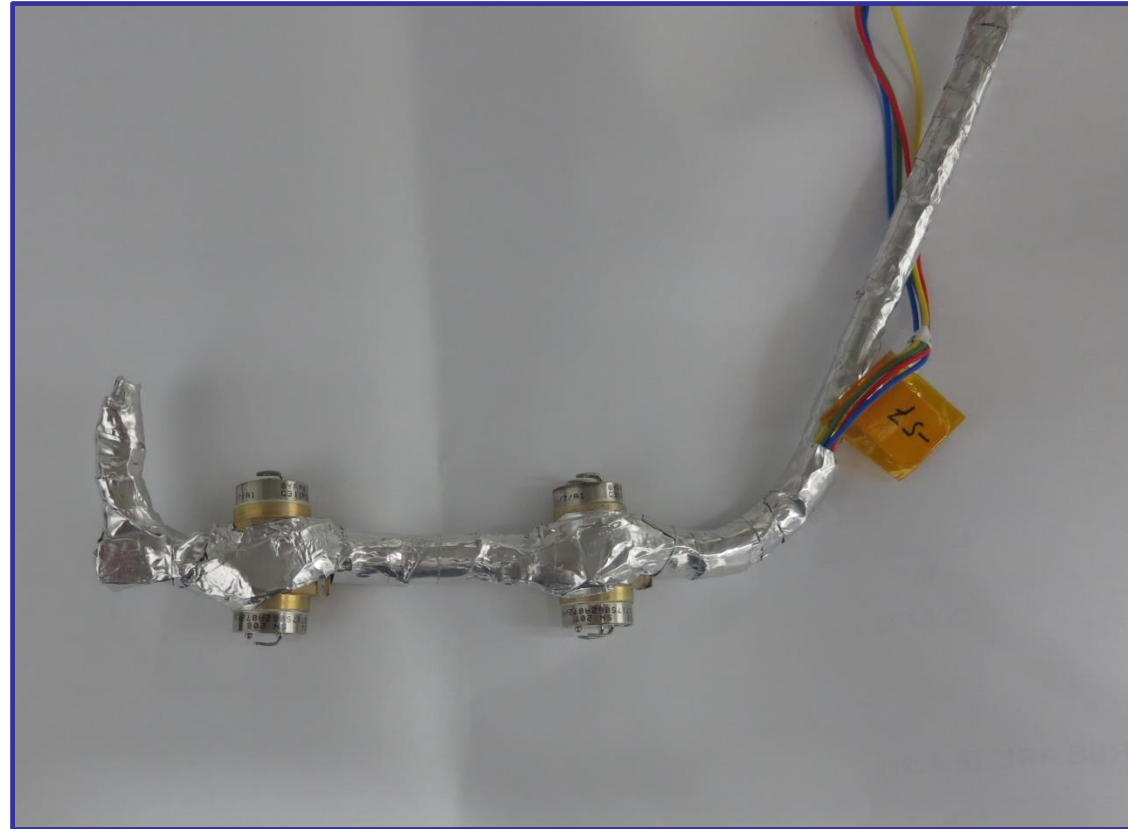
- Since there was no readily available flight experience with this layered construction, an Engineering Development Unit (EDU) was fabricated and tested.
- Ambient testing of the flight installed auxiliary heater, as well as the underlying existing heater, was performed to verify operation.

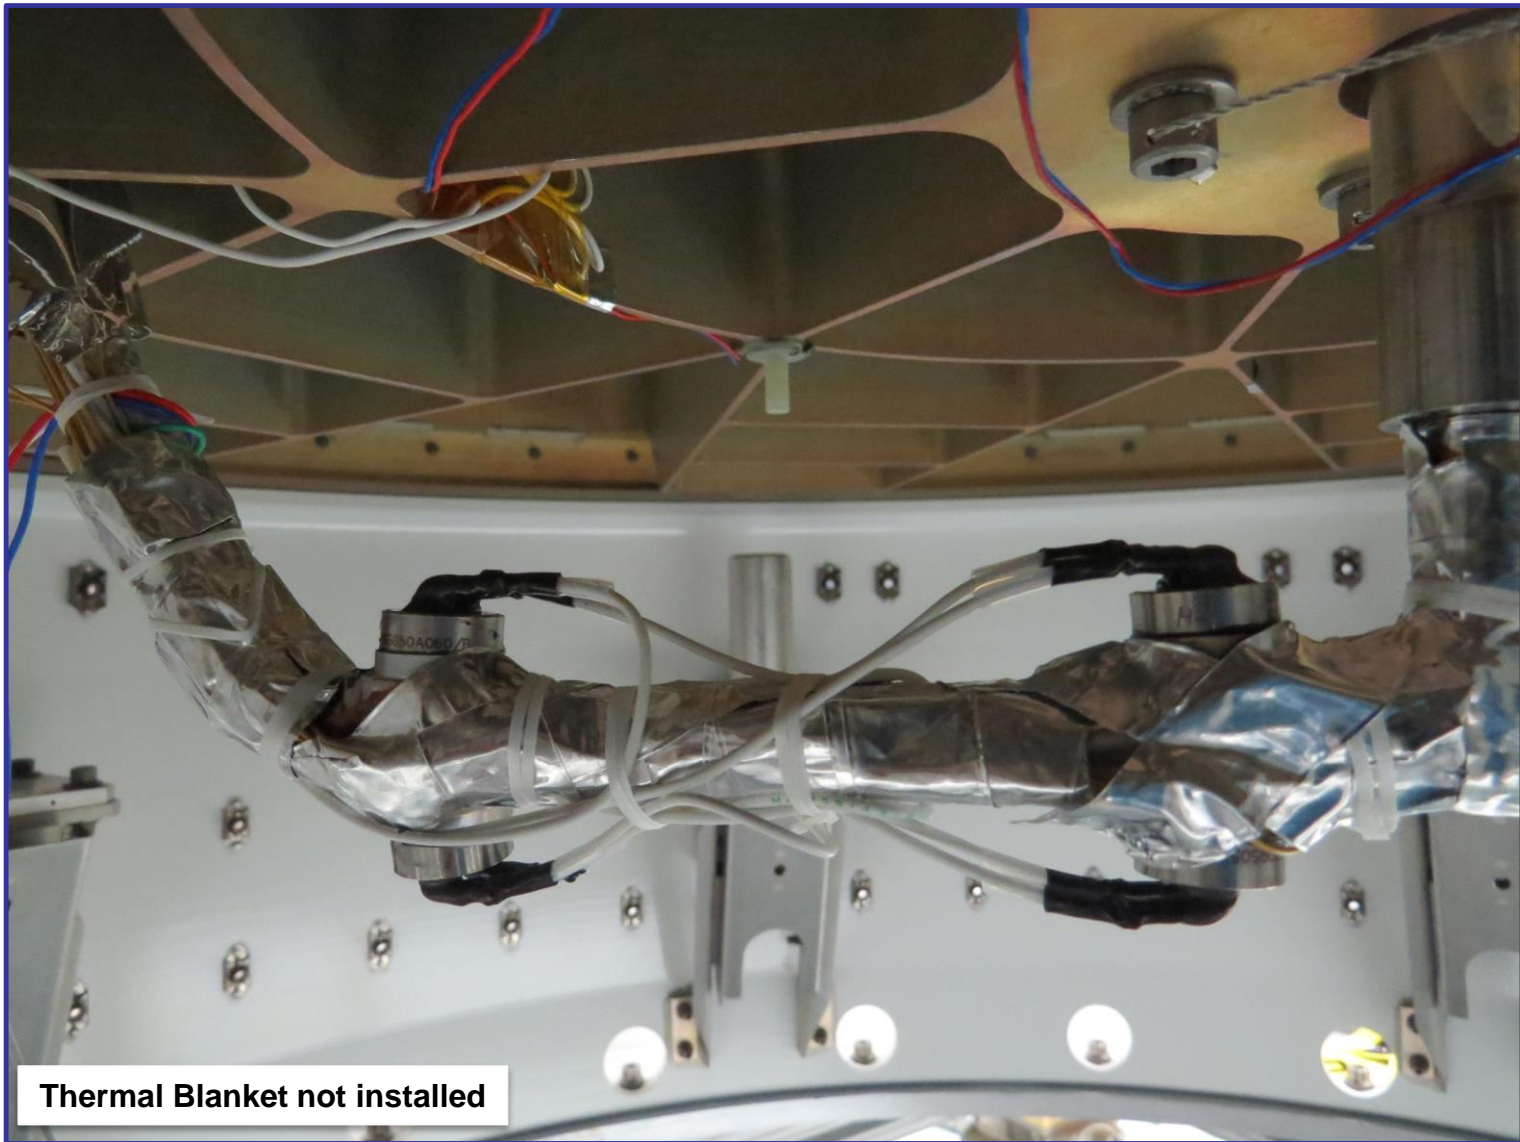
Propulsion - Flight Installed Auxiliary Heater

Thermal Blanket not installed

- Wires had to be run to the bottom of the propulsion module to power the flight auxiliary heater.
- The high gain antenna and the prop module access panel had to be removed to gain access to the inside of the prop module for wire routing.
- Several mli blankets had to be removed to install the auxiliary heater.
- The flight installation had to be tested.

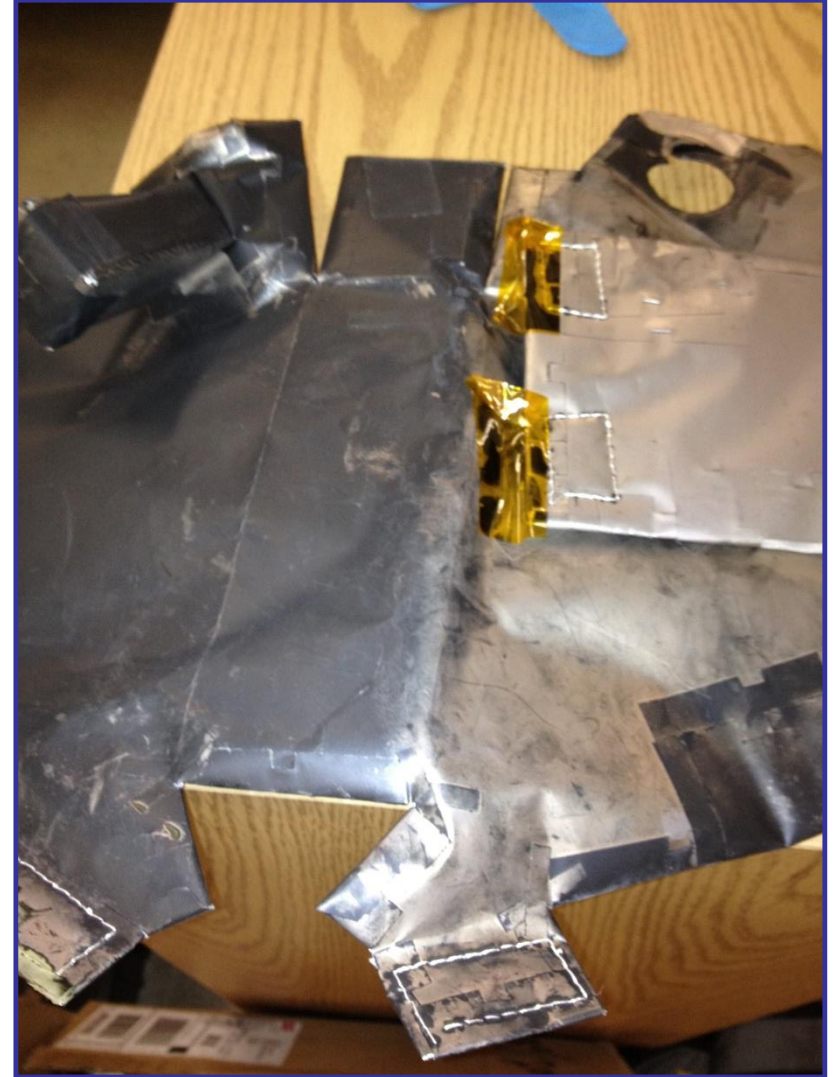
- Germanium missing from most areas of germanium black Kapton MLI; replaced outer layers.
- Several blankets totally missing.
- Had to figure out the original location of many others.

- *MLI in long term storage should be in a humidity controlled environment and handling minimized.*
- *Thermal Project Engineer should understand and inform Project Management regarding the scope and complexity of thermal blanket fabrication and installation.*
- *Individual blanket designs and fabrications should be identified with sufficient time allocated for these activities in the I&T schedule.*
- *Individual blanket installations should be identified in the I&T schedule as any other hardware installation task, rather than specifying a general time period for overall installations.*

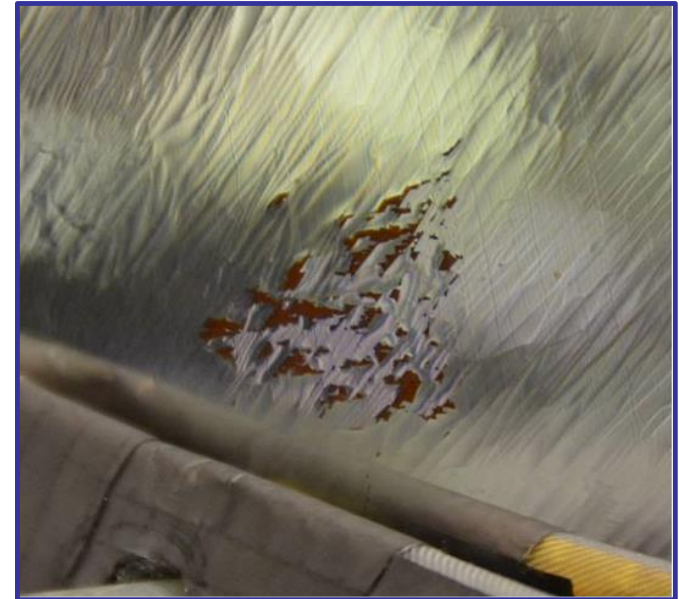
- Most thermal control surfaces showed damage due to mishandling, although the optical properties hadn't changed during storage.
 - NS43C white coatings touched up with Z93C55 white paint.
 - High temperature E-glass MLI near the thrusters were shedding particles; required stainless steel shells be installed to contain the particles.
 - Phosphoric-acid etched nickel inside the NISTAR baffles began flaking. Instrument was taken apart, surfaces stripped and recoated with Z306 black paint.
 - Root cause of shedding not clear.

- *Schedule and budget for increased cleanings and inspections of coatings throughout the I&T campaign.*
- *Early on in the refurbishment consider stripping and re-applying coatings to all shedding surfaces.*
